Analyzing the degradation of roadside infrastructure

Luke Strand Augustine

A THESIS

Department of Civil Engineering
College of Engineering

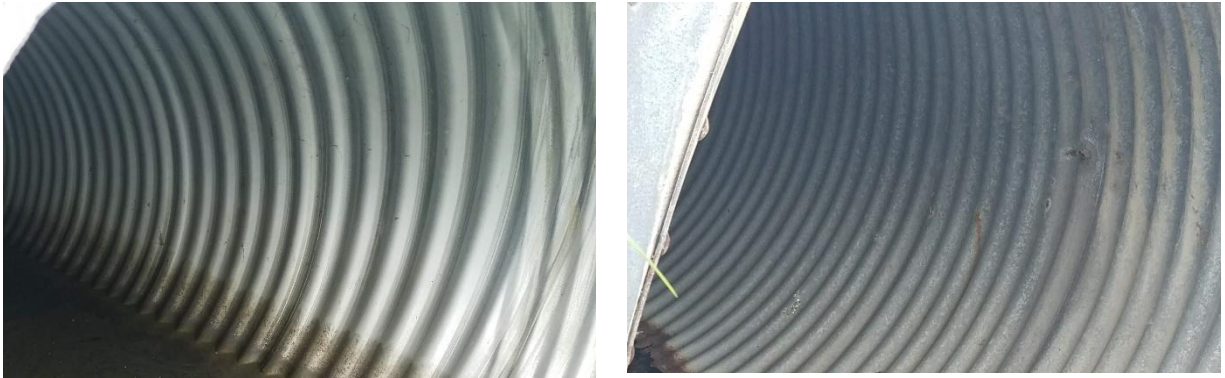
Fig. 2.2 Loss of spelter in CMP US-56/9-yr

There are two main types of corrosion: uniform and non-uniform corrosion (Cicek, 2014). Uniform corrosion occurs when corrosion is evenly distributed over the surface of the metal. The loss of thickness in the metal is relatively shallow when compared to non-uniform corrosion. Uniform corrosion is commonly attributed to atmospheric corrosion, corrosion in water, and soil corrosion, all of which require consistent coverage of the metal (Cicek, 2014). Fig. 2.2 shows the beginning stages of atmospheric corrosion as the spelter, (i.e., the protective zinc coating) on this particular CMP is corroded.

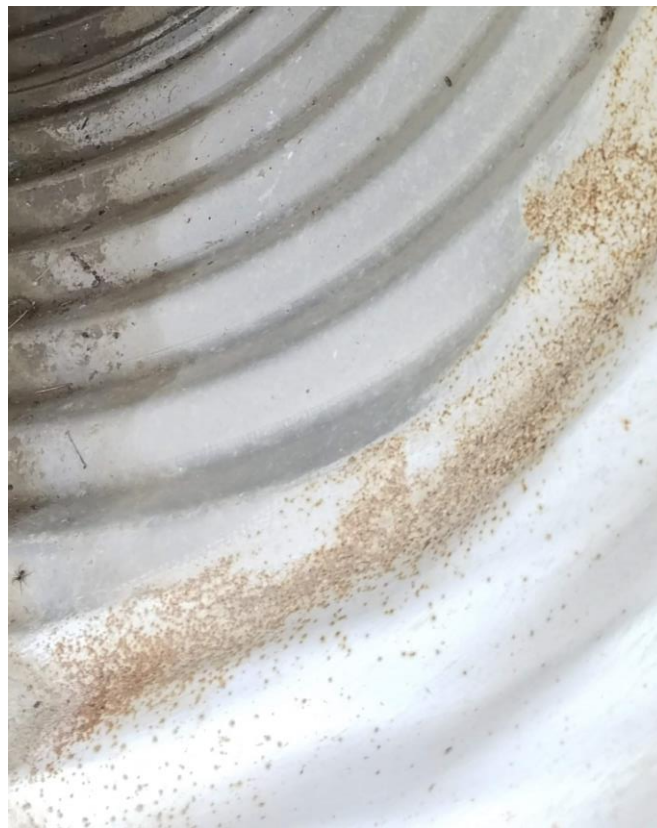
Fig. 2.3 Pitting corrosion in corrugated metal pipe

The second type of corrosion, non-uniform corrosion, is localized. The localization can cause perforations and significant material loss in small areas (Cicek, 2014). Common types of non-uniform corrosion are galvanic corrosion and pitting. An example of pitting can be seen in Fig. 2.3.

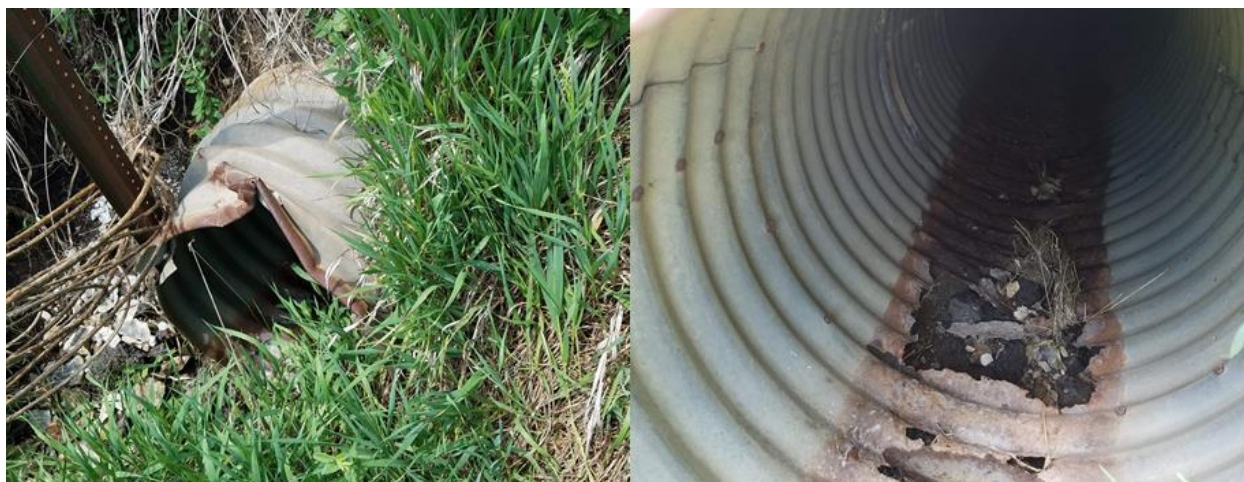
Fig. 4.1 Side A of sample CMP K-63/80-yr, (a) external, (b) internal

The external face of Side A displayed light rust film near the soil cover (Fig. 4.1a). Inside of the pipe, both the crown and side faces had lost the entirety of their spelter, while the invert had lost large areas of metal (Fig. 4.1b). These ratings were converted to the numerical values 80 for the external face, 85 for the crown, 85 for the side, and 0 for the invert in order to calculate the average value. This value, labeled general condition, was found to be 62.5 for Side A. The other end of the pipe, Side B, also showed light rust film on the external face (Fig. 4.2a). Its interior faces were also similar in that both the crown and side faces had lost their spelter (Fig. 4.2b). The difference between the two ends were found in the invert, where Side B had not lost any material. The invert of Side B exhibited heavy rust approximately $\frac{3}{4}$ through the metal; it did appear to be nearing the manifestation of holes because of the heavy rust (Fig. 4.2b). The converted numerical ratings were 80, 85, 85, and 30. The resulting general condition for Side B was found to be 70. Table 4.1 shows a complete dataset for the sample CMP. A Collins rod soil resistivity rod was used in three separate locations near the CMP to determine the average resistivity of the soil surrounding the CMP to be 700 Ohm-cm.

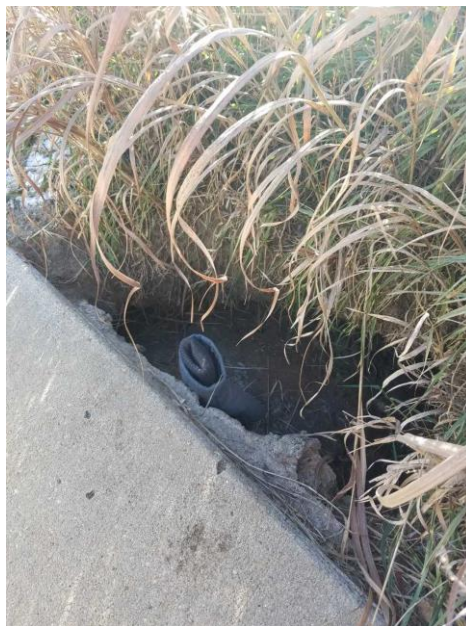
Fig. 4.15 Hole in MSE wall at US-24 and Camp Creek Rd., Belvue Kansas

The location of this MSE wall ran parallel to train tracks West of Belvue, Kansas. This wall showed many holes and channels that had formed directly behind the face of the wall. The severity of the one of the holes can be seen in Fig. 4.15.

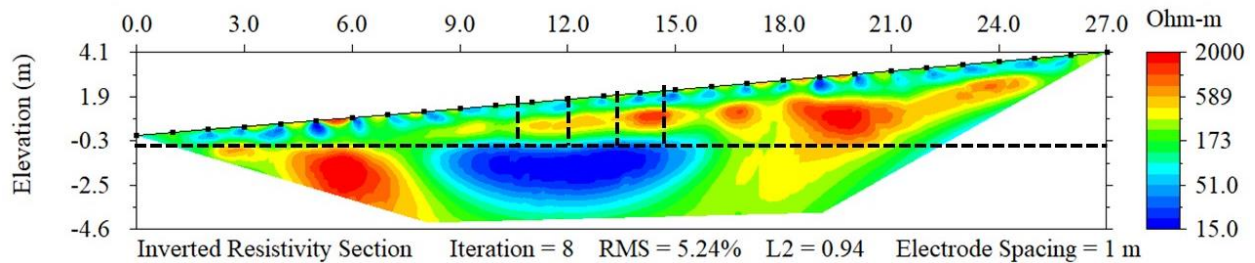
Fig. 4.16 Dipole-Dipole array with 1 m spacing at US-24 and Camp Creek Rd., Belvue, Kansas

Without any prior knowledge it was expected that this wall would not have homogenous resistivity readings due to the loss of material and erosion. Because of the incline of this wall, only one survey was taken at the top of the wall. The results of the 1 m Dipole-Dipole are shown in Fig. 4.16. The results supported the predictions that the backfill would not produce homogenous results. Instead, the results show pockets of loose material in red and saturated pockets in blue.
